**AVIATION INVESTIGATION REPORT
A01P0003**

LOSS OF MAIN ROTOR DRIVE

**HAYES HELI-LOG SERVICES LTD.
SIKORSKY S-61N (SHORTSKY) HELICOPTER C-FHFS
PORTEAU COVE, BRITISH COLUMBIA
15 JANUARY 2001**

Report Number A01P0003

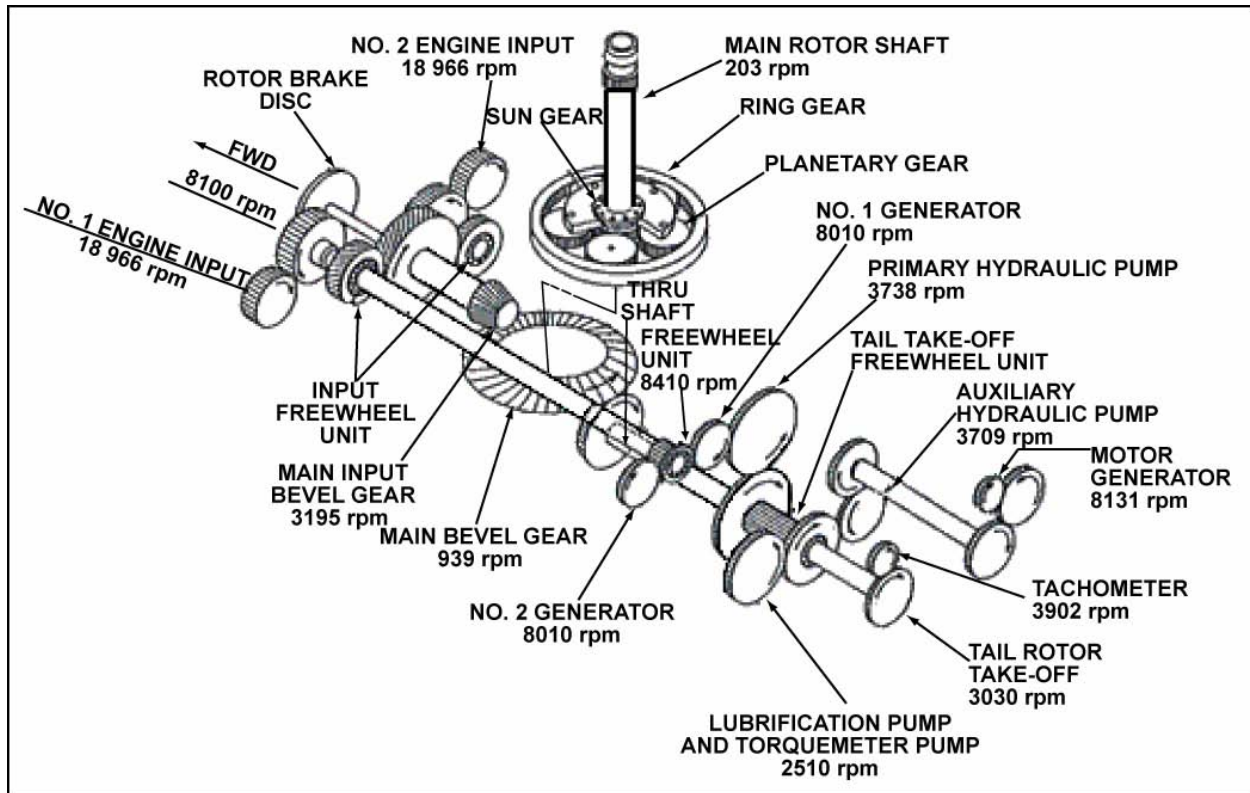
Figure 1. Main transmission

Further disassembly of the main transmission (see Figure 1) revealed unusual gear wear patterns, fretting, and misalignment of the No. 3 and No. 4 bearing outer races relative to the steel liners. This was evident by the following:

- The spiral bevel pinion and the main spiral bevel gears were worn excessively; however, every fifth tooth had relatively little wear.
- Measurements taken during this disassembly to determine the appropriate shim thickness between the input housing and the transmission lower housing varied from 0.039 inch to 0.048 inch (a difference of 0.009 inch). The required shim thickness was calculated to be 0.033 inch at the last overhaul. The same measurements taken at the last overhaul varied from 0.024 inch to 0.053 inch (a difference of 0.029 inch). Typical shim thickness in this application is 0.038 inch to 0.044 inch.

- At disassembly, the backlash between the spiral bevel pinion and the main spiral bevel gears was 0.022 inch. At the last overhaul, the backlash was set at 0.016 inch (the maximum allowable).

- Wear of the spiral bevel pinion and the main spiral bevel gears was not sufficient to account for the change in backlash measurements between overhaul and the post-accident teardown inspection.

- Dowels that align the cover and input housing were loose.
- Fretting, galling, corrosion, and scoring were found on the aluminum pilot liner around the No. 4 bearing.

- The steel liner ring in the lower housing was found to be skewed. (The side opposite to the dowel pin, which retains the liner, had shifted from the centre of the transmission.)

- Fretting was found under the No. 3 and No. 4 bearing inner races on the input pinion (spiral bevel gear).
- The input housing casting was found to have contacted and fretted the lower housing casting near the No. 6 bore.

- The input housing twist was measured to be right 0.110 inch. (The maximum allowable off centre is 0.125 inch, beyond which the housing must be scrapped.)

- The oversize liners machined for the bearing bores were of incorrect dimensions: the radius was 0.016 inch instead of 0.040 inch.
- The No. 3 and No. 4 liners were embossed with lettering and numbering stamped into the bearing outer races.

The spiral bevel pinion and the main spiral bevel gears demonstrated wear patterns consistent with improper alignment. In addition, there was a difference of 0.029 inch in the measurements of surfaces between the No. 4 bearing inner race and the fixture at the time of overhaul build-up. It is therefore concluded that these gears were misaligned during the build-up at the time of the last main-rotor transmission overhaul. This would have substantial effect on gear operation and could cause torsional oscillations or torsional vibrations. Gear tooth wear measured during the teardown inspection was not sufficient to account for the change in backlash at overhaul and during the teardown inspection. Gear tooth wear and changes in measurements of the surfaces between the No. 4 bearing inner race and the fixture indicate that there was movement of the No. 3 and No. 4 bearings, the spiral bevel pinion, and the main spiral bevel gears since the time of the overhaul.

Fretting under the No. 3 and No. 4 bearing inner races on the input pinion and on the aluminum pilot liner around the No. 4 bearing, along with the loose dowel pins, is indicative of an abnormally high level of vibrations in the transmissions during their operation leading up to the accident. The only anomalies identified during the teardown that could cause such vibrations were the misalignment and subsequent movement of the Nos. 3 and 4 bearings, the spiral bevel pinion, and the main spiral bevel gears. It is therefore likely that vibrations and high forces initiated movement of the misaligned components and that movement caused the backlash to be extremely out of its specifications. This would then increase vibrations and movement of the casting as the dowel pins became loose. It was not determined why the spiral

On 03 October 2002, the TSB forwarded an Aviation Safety Advisory (A020028-1) to TC and Sikorsky Aircraft Corporation. The advisory suggests that, because of the consequences of gear misalignment during the build-up at main-rotor transmission overhaul, TC and Sikorsky Aircraft Corporation may wish to review the manual governing overhaul procedures for main-rotor transmissions in Sikorsky S-61 helicopters, and incorporate multiple measurements and maximum differential between measurements from the datum fixture and the No. 4 bearing inner race. Additionally, TC and Sikorsky Aircraft Corporation may wish to incorporate a gear pattern check at transmission build-up.

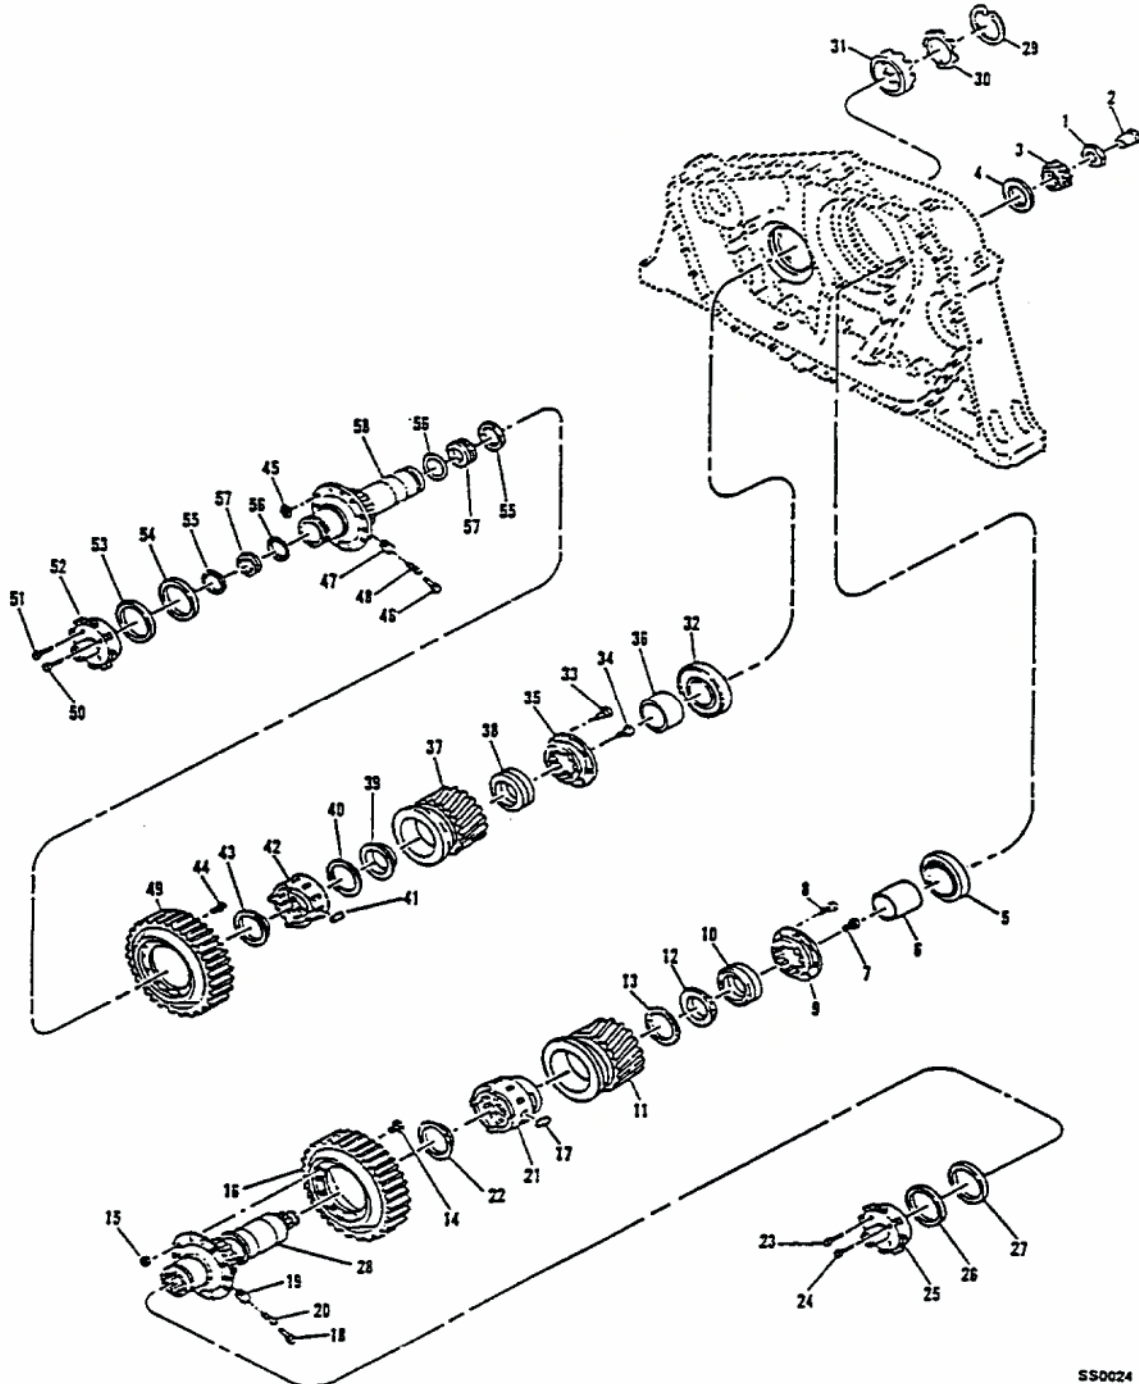
FIGURE 149A. MAIN GEAR BOX INPUT FREE WHEEL UNIT QUICK CHANGE ASSEMBLY

The main-rotor transmission, which had accumulated approximately 710 hours since its last overhaul, was also subjected to a post-accident teardown inspection, conducted at an approved Sikorsky main transmission overhaul facility in Richmond, British Columbia, under the supervision of TSB investigators. Initial disassembly of the front section revealed extensive wear and damage to both input freewheel units (IFWUs) (see Appendices A1 and A2).

The IFWUs had been replaced, as a matter of practice, about 500 hours after the last main-transmission overhaul. The IFWUs that were removed demonstrated normal wear. The replacement IFWU (part number 61047-35000-060) had accumulated approximately 210 hours of flight time and about 70 engagements since installation. They were made up of new cams and rollers. During routine maintenance before the accident, there was no significant metal found in the main-rotor transmission oil filters. Also, no illuminated chip lights were reported. After the accident, during a teardown inspection of the main-rotor transmission, metal particles were found in the transmission, but chip sensors were not activated. A more detailed inspection of the metal found in the transmission oil filters revealed numerous flakes of bronze, some flattened. The bronze Oilite bushings (part number S6135-20459-101), on which the roller retainer sits, showed damage consistent with that found when they are comprised of material that cannot withstand the normal forces, or that have been exposed to an abnormally high level of vibrations. Other components of the IFWUs showed the following signs of instability, slippage, and skidding:

- The camshaft flats were dented by the rollers.
- The rollers had flat spots and were contaminated with bronze.
- The input gear housing was contaminated with bronze, and the inner surfaces were heavily damaged by slipping and skidding of the rollers.

- The roller retainers had dents along the lower surface on the back side of the tangs, scores and grooves on the inside between the roller pockets, and uneven wear in the pockets.
- The bronze Oilite bushings were extremely worn and showed cracks and bending.

Information received about three years after the accident revealed that the Oilite bushings supplied by Sikorsky were not manufactured properly. The bushings had areas of large pores and incomplete sintering. These Oilite bushings were subject to premature wear and damage from normal use. This created instability of the rollers because the roller retainer rests on the Oilite bushings. The instability, increased pinch angle of the rollers and cams (caused by dents in the cams), and bronze contamination caused the rollers to slip or spit out, disengaging one of the IFWUs. Because the other IFWU was also worn and contaminated, it failed within a very short time of the initial IFWU failure, and total drive to the main rotor was lost. (When one IFWU disengages, all power demanded by the rotor system is transmitted to the remaining IFWU, increasing the likelihood that the remaining IFWU will quickly fail.) When the load of driving the main rotor was lost, the engines oversped and shut down. Rotor rpm decayed, and control was lost.

1. An Oilite bushing broke down because it was manufactured with large pores and incomplete sintering. This created instability of the rollers because the roller retainer rests on the Oilite bushings. The instability, increased pinch angle, and bronze contamination most likely caused the rollers to slip or spit out, disengaging the input freewheel unit (IFWU).
2. When the first IFWU disengaged, all power demanded by the rotor system was transmitted to the remaining IFWU, which was worn and contaminated, causing it to fail within a very short time of the first failure, and total drive to the main rotor was lost, leading to the loss of control of the helicopter.

On 11 August 2003, Sikorsky Aircraft Corporation issued revision B of Alert Service Bulletin 61B35-67B establishing criteria for inspection, overhaul, and removal of the IFWUs. The bulletin defined external lift cycle and repetitive external lift (REL) operations, and it established a maximum time between overhaul (TBO) for REL operations at 500 hours or 7500 cycles, whichever comes first. It also made provisions for operators and repair facilities to document measurements and report their findings to Sikorsky. In part, the bulletin refers directly to the Oilites and requires that all Oilites be replaced during overhaul or repair of the IFWU. Sikorsky also indicated that it has upgraded the inspection criteria for the manufacturing of the Oilites.
